# 132 Park Place Drive

## Structure Fire After Action Review

Petaluma Fire Department | Incident: September 13, 2026

## **Electrical Panel Arc**

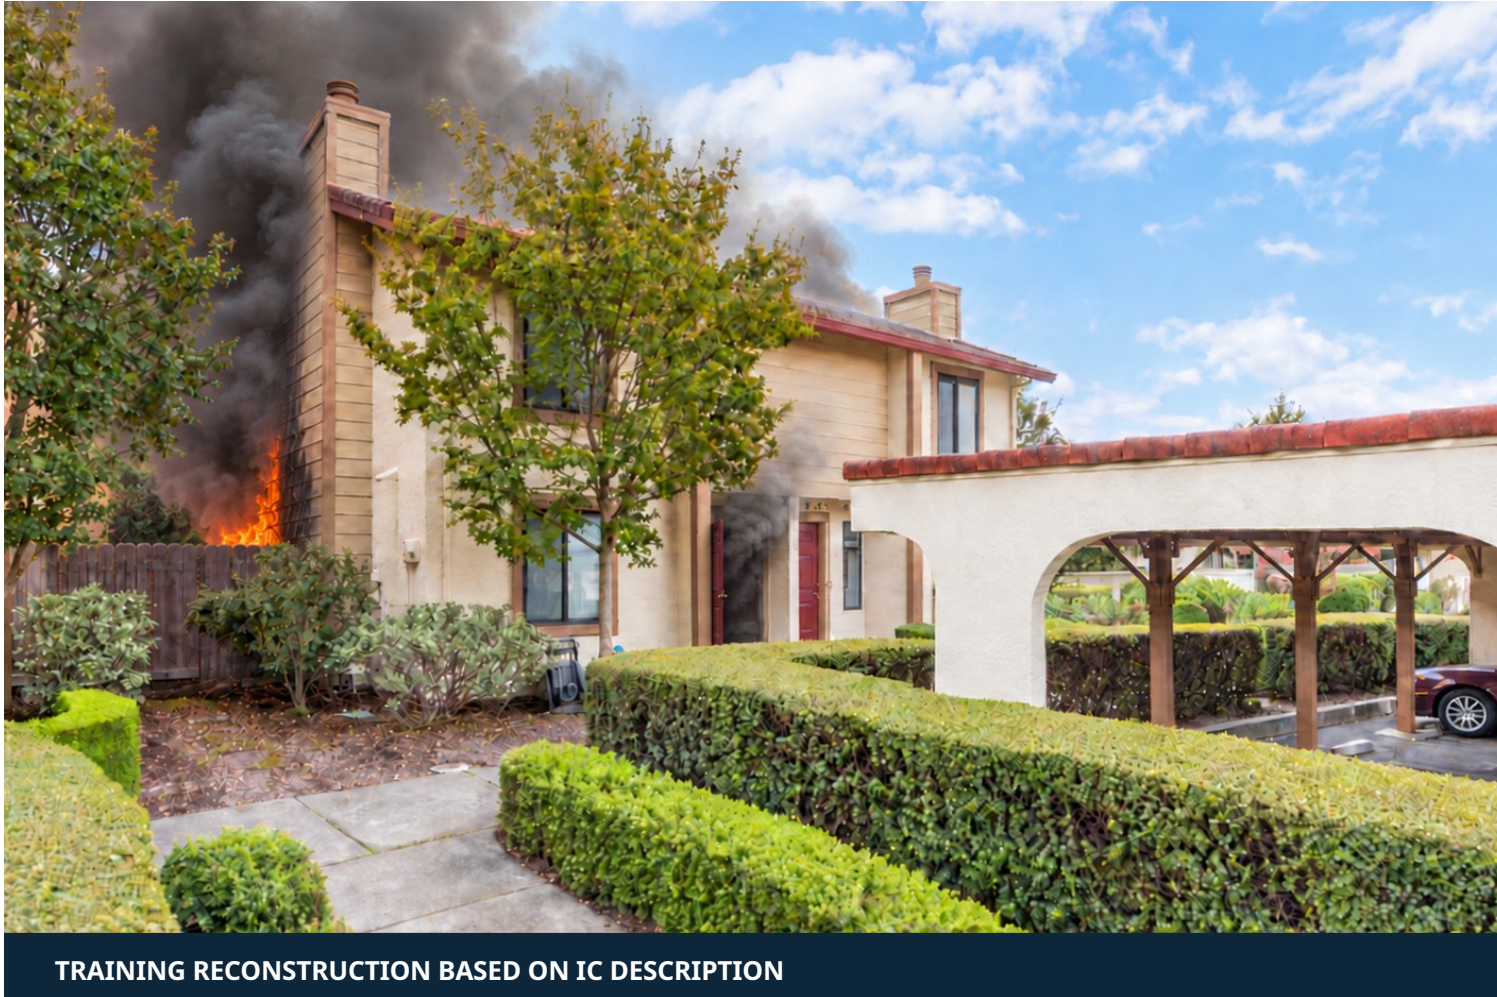
- Heavy gas-fed fire in the kitchen and rear room
- Fire overhead 5–10 feet inside the Alpha entry
- Fire out the Bravo kitchen window and likely the Charlie-Bravo patio opening
- Siding involved with extension into the attic
- Detached Bravo duplex threatened
- Interior crews reported extreme heat

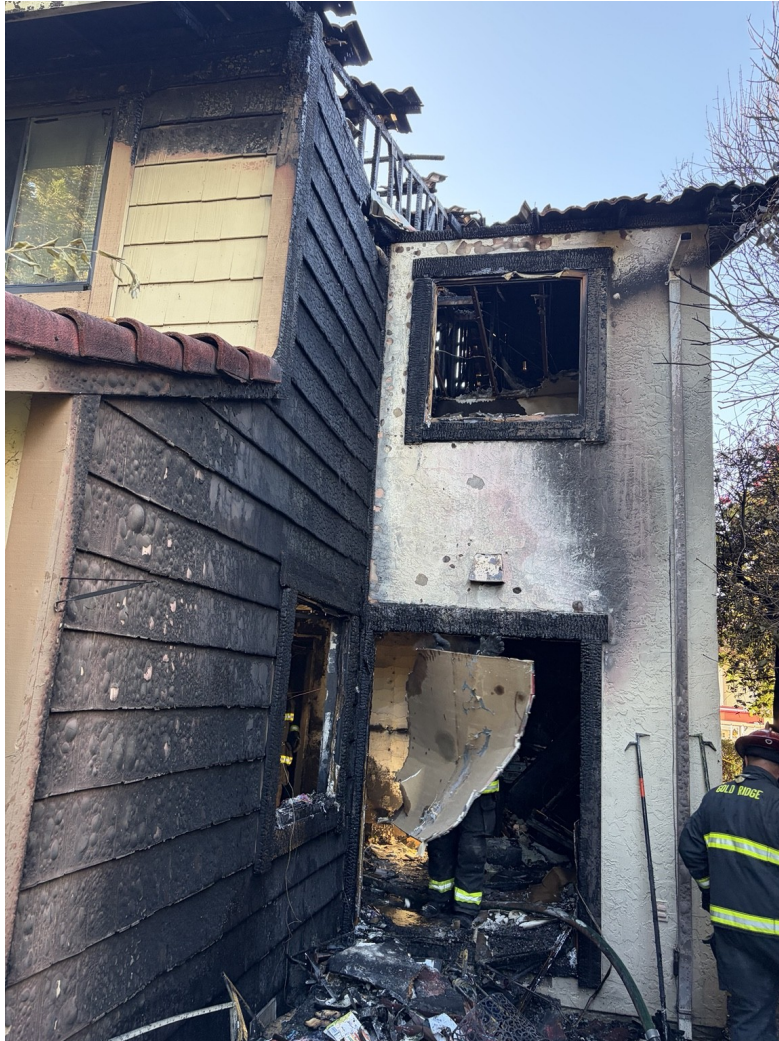
POST-CONTROL INCIDENT PHOTO

- Fire ran the Bravo siding from the kitchen level into the attic and roof area
- Exterior walls and openings showed heavy heat and flame impingement
- Roof members were exposed with heavy charring beneath the tile roof
- Fire damage and the ventilation opening reduced confidence in the roof system

Both duplex units were red tagged due to fire damage, limited attic access, compromised roof support, and tile-roof dead load.

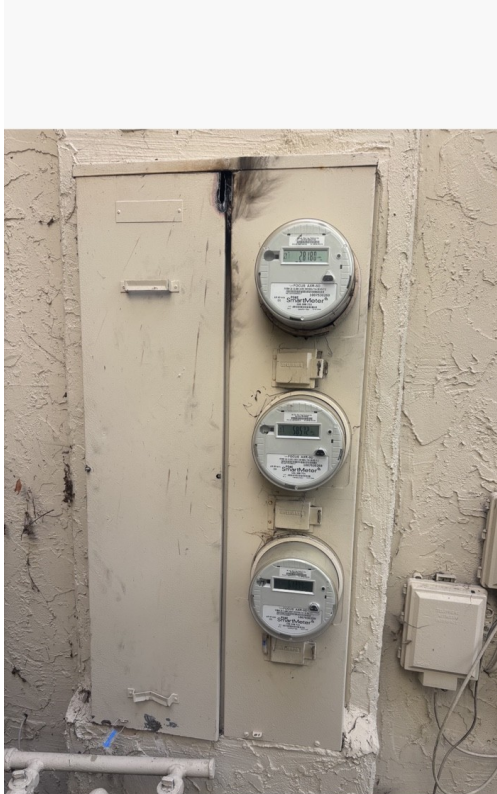
Arcing and heat damage at the upper cabinet seam

The cabinet arced when a firefighter attempted to open it. No injury occurred.

- An attempt was made to open the electrical panel cover, causing an arc.

**Individual breakers located under each meter.**

- Personnel must be able to positively identify electrical equipment before attempting to open or manipulate.
- Unfamiliar or high-voltage equipment should be isolated and left for PG&E.

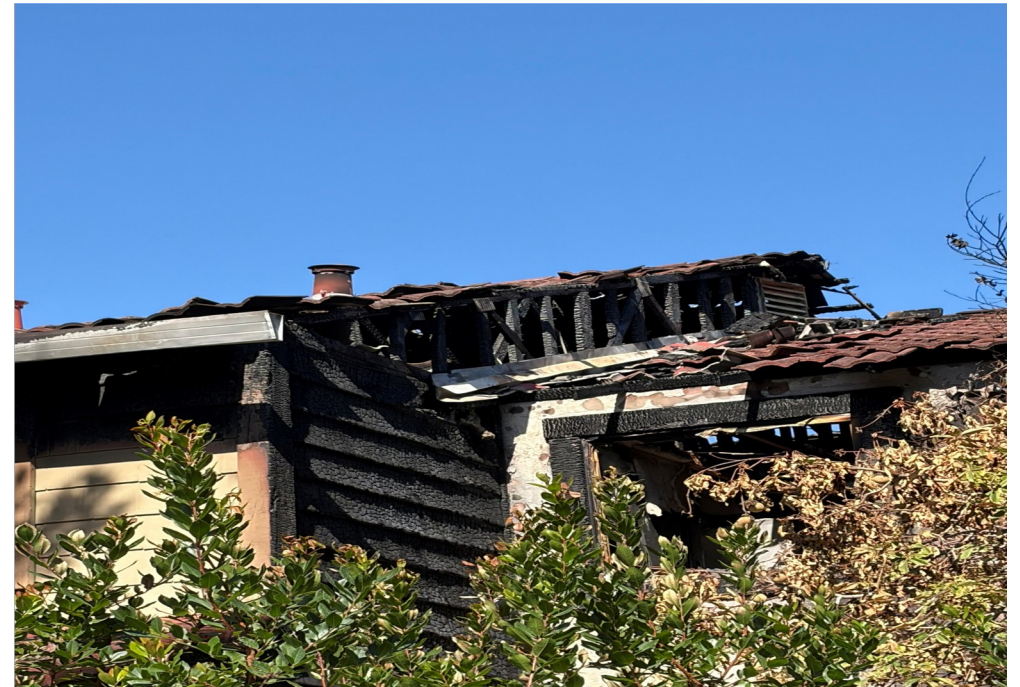
- Tile added considerable dead load
- Roof members were exposed with heavy charring beneath the tile roof

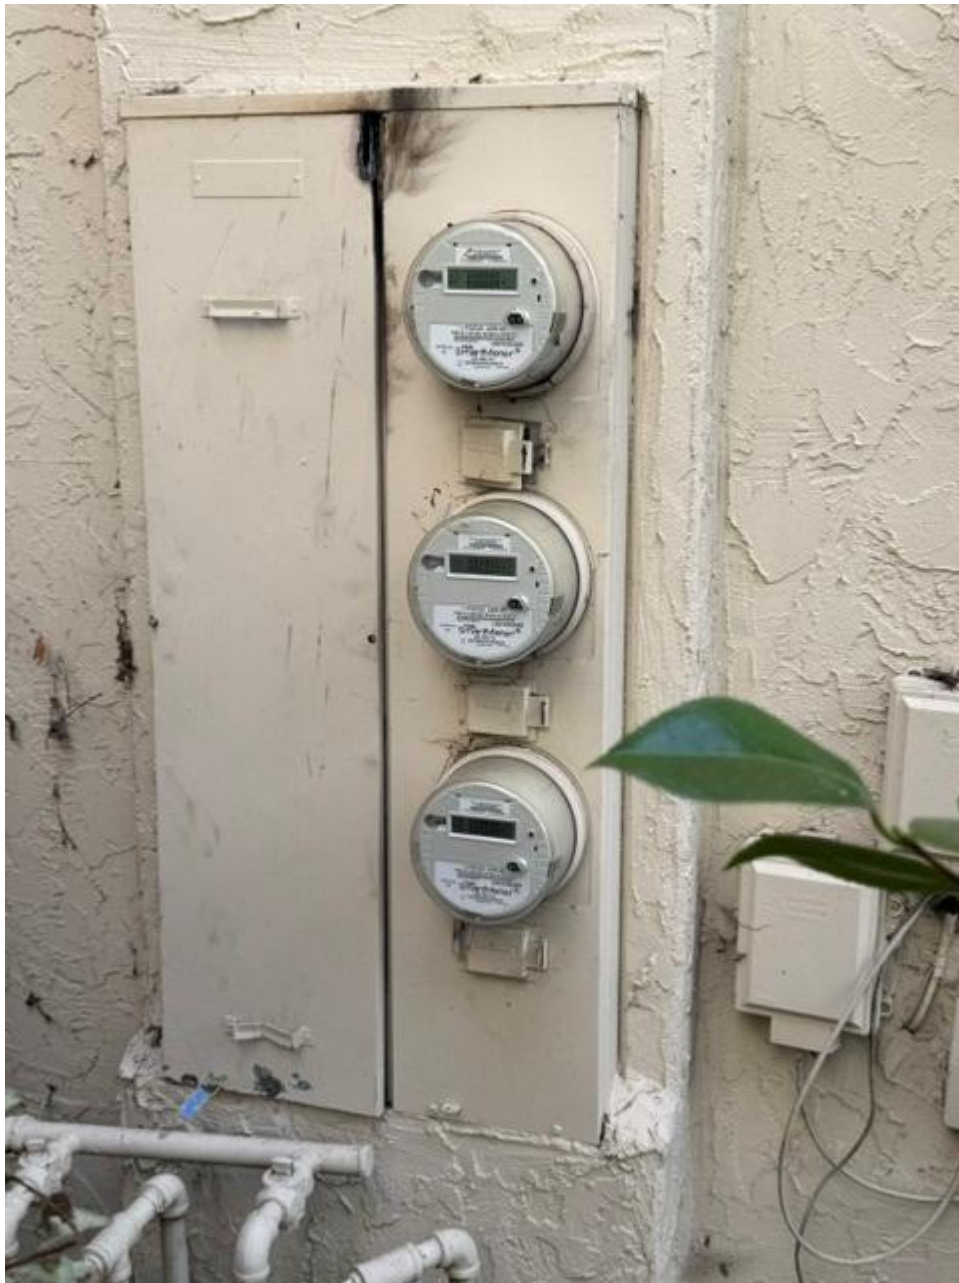
Medic 102 arrived at the same time, and the IC assigned them to Two Out. While conducting a 360 and gaining situational awareness, Medic 102 began securing utilities. The Gas meter and electrical panel for the duplex were located on the Bravo side of the structure closest to the Alpha-Bravo corner. The electrical meters were on the right side, and what appeared to be an electrical panel was on the left. Medic 102 noted the panel had been heavily painted over, and two wing nuts held the panel cover shut. It was assumed that the wing nuts were in place to keep tenants from tampering with the breakers. Medic 102 removed the wing nuts by hand, then lifted the panel cover from the bottom grab handle, anticipating a hinge at the top of the box. As Medic 102 lifted the panel, the top began to fall. Medic 102 let go of the panel. The top of the panel fell inwards, contacting two exposed wires. This completed a circuit and caused an arc. The

panel rested on the wires, gas meter, and the ground.

- The incident did not result in any injuries to personnel operating on the fire ground.
- The electrical panel cover sustained damage. See attached photos.
