# 132 Park Place Drive

## Structure Fire After Action Review

Petaluma Fire Department | Incident: September 13, 2026

## **Electrical Panel Arc**

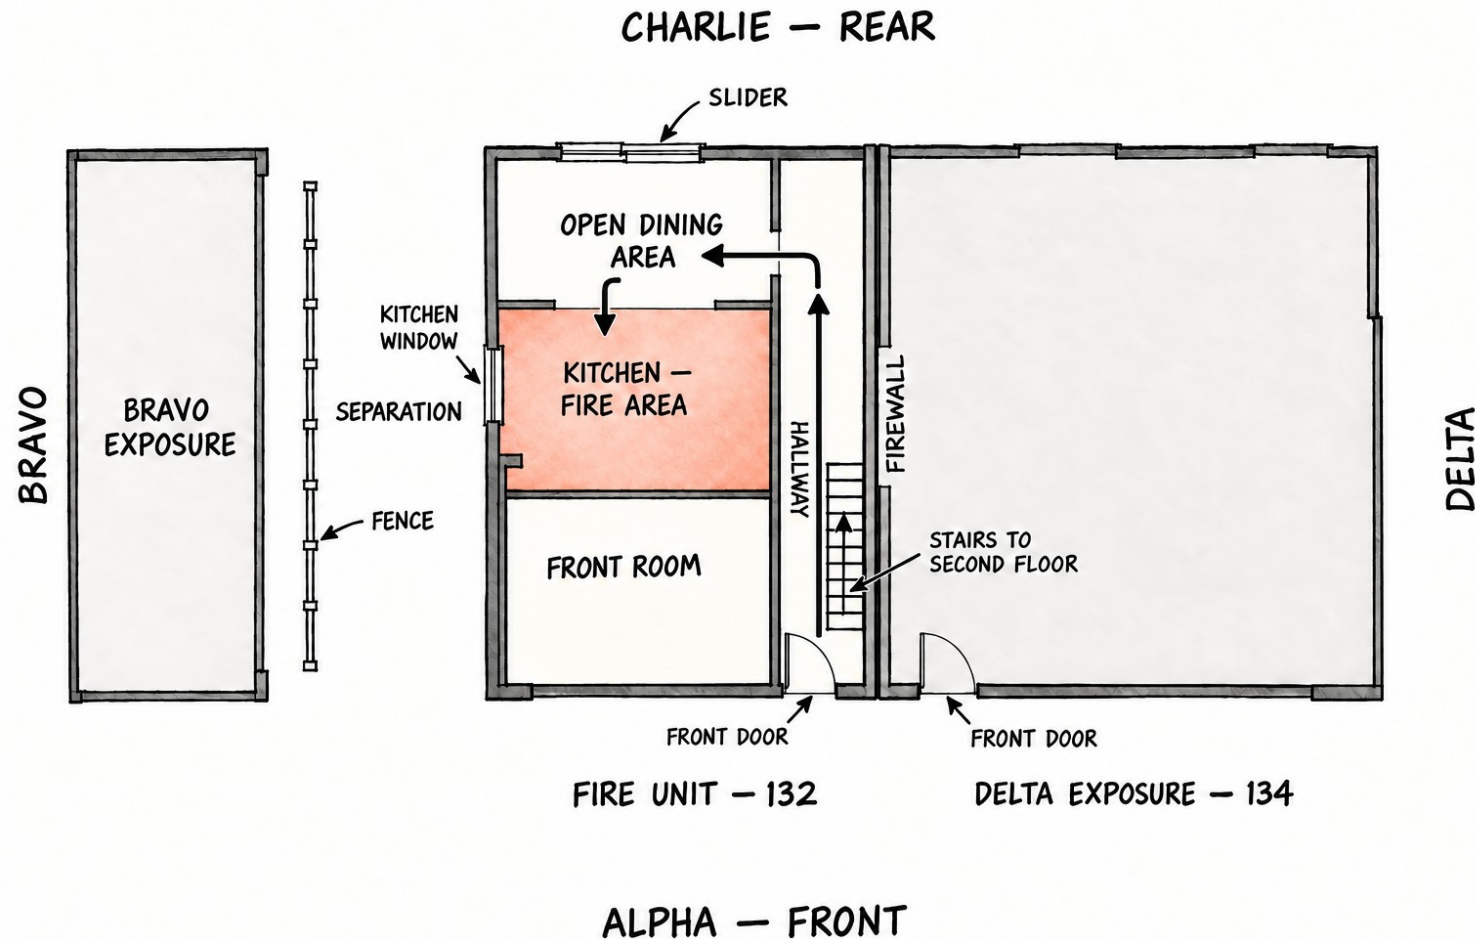
04

From Alpha, the line moved down the enclosed hall to Charlie, left through the dining area, then left again into the kitchen.
